INTERPLASTIC

# CASE

The critical pipe line rehabilitation at Westwood Lakes

Extraordinary  
Properties make  
CoREZYN®  
Vinyl Ester  
*“Resin of Choice”*

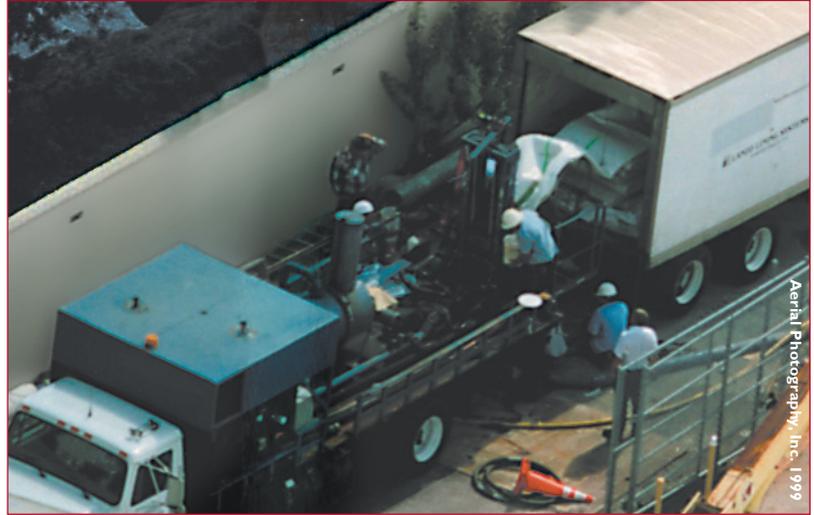
The project consumed 10,670 pounds of vinyl ester resin.

Prior to the tube's arrival at the job site, an inversion column was set up. Due to the tube's large diameter, a thrust block was used in the sending manhole to counter inversion forces during early installation stages. A day before the installation, CoREZYN vinyl ester resin was catalyzed and pumped into the tube, which was carried along on a conveyor and carefully monitored to ensure uniform wall thickness. Because of the number and size of the defects plus the aggressive influent water into the pipe, an additional 5% sacrificial resin was used to prevent washout or contamination of the 19.5 mm finished design thickness. The project consumed 10,670 pounds of vinyl ester resin.

The wetted-out tube was loaded into a refrigerated vehicle and transported to the job site during the night to avoid possible traffic delays and the heat of the Miami sun. When the 11,000-pound tube arrived, an on-site water source was used to inflate the tube during the inversion process. Once inflated, the tube's internal water temperature was ramped slowly to 140oF (the curing threshold) and maintained for an hour, allowing the line to stabilize. This also allowed the resin to saturate the existing

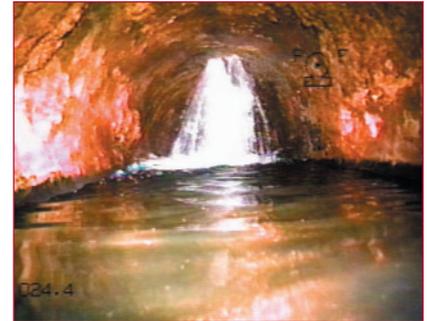
With the bypass in place, the existing line was cleaned while Lanzo's crew conducted a closed-circuit video inspection to reveal the nature and location of the pipeline defects. The video data identified several major leaks. Hydrogen sulfide attack on the crown of the pipe was compounded by the scouring action of high velocity flows.

"The cast iron pipe also had major scaling and oxidation byproduct deposits which needed to be removed, giving us a smooth, symmetrical surface for the new liner," said Tingberg. The cleaned pipe's effective diameter was 32-inches instead of the 30-inch standard that Lanzo anticipated. "We had a 30-day window to complete the job, so we rush-ordered a special tube to be air-freighted to our Pompano Beach (FL) plant. There it was fitted with turn ropes and further customized to meet the host pipe's geometry."

Pipe Before

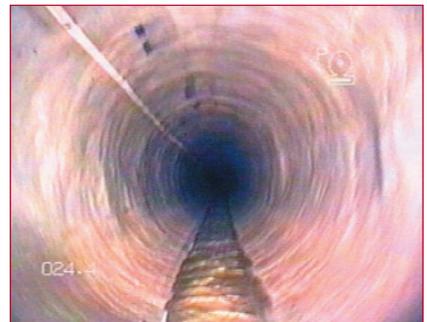
Pipe After

defects in the host pipe. Then the temperature was increased to 180°F and maintained for the balance of the cure cycle. After that, Lanzo's crew reinstated pipe ends and laterals and post-televised the line. Samples were drawn and sent to an independent testing laboratory to document the flexural strength and modulus achieved in the field. Additionally, this information proves the quality of the wet-out and completeness of the cure. It also validates the design basis for the selection of the wall thickness. The rehabilitated pipe has a 50-year life expectancy.
