INTERPLASTIC

CASE

## One Resin Handles Three Corrosive Environments in One Process, Outperforming 316 SST and Providing Huge Savings.

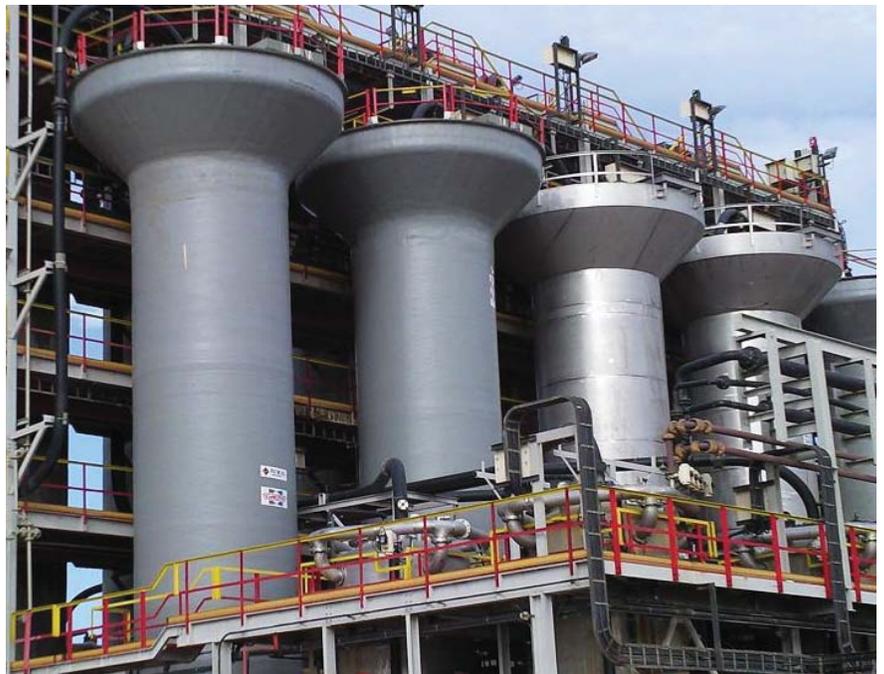
Sequential elution is a process for purifying gold ore, which when mined is complexed with silver, mercury and other impurities. The ore must be eluted sequentially with various eluants in order to separate it into its component parts. The process subjects the columns (pictured) to chemical environments ranging from basic (NaClO-sodium hypochlorite and NaOH-sodium hydroxide) to chloride rich (NaCl-sodium chloride) to highly acidic (20% H<sub>2</sub>SO<sub>4</sub> -sulfuric acid).

Using both case histories and technical data, they convinced AGA to replace 316 SST as the material of construction with vinyl ester based FRP. More specifically, FRP fabricated with a CoREZYN vinyl ester from Interplastic Corporation, CORVE 8300.

It was agreed the first elution column would serve as the pilot test case. It was fabricated and put into service October of 2008. By February of 2009, only four (4) months later, AGA was so pleased with how the initial column was holding up, they ordered four (4) more to immediately replace all five (5) 316 SST elution columns with FRP columns fabricated with Interplastic vinyl ester resin CORVE 8300.
